Department: **AFTER SALES**Subject: **TECHNICAL BULLETIN D-167**Date: **15.6.2010**Product: **PLANMECA COMPACT i**Originator: **Jukka Fallström**Issued by: **Maija Lampinen**

Instrument hoses of Planmeca Compact units

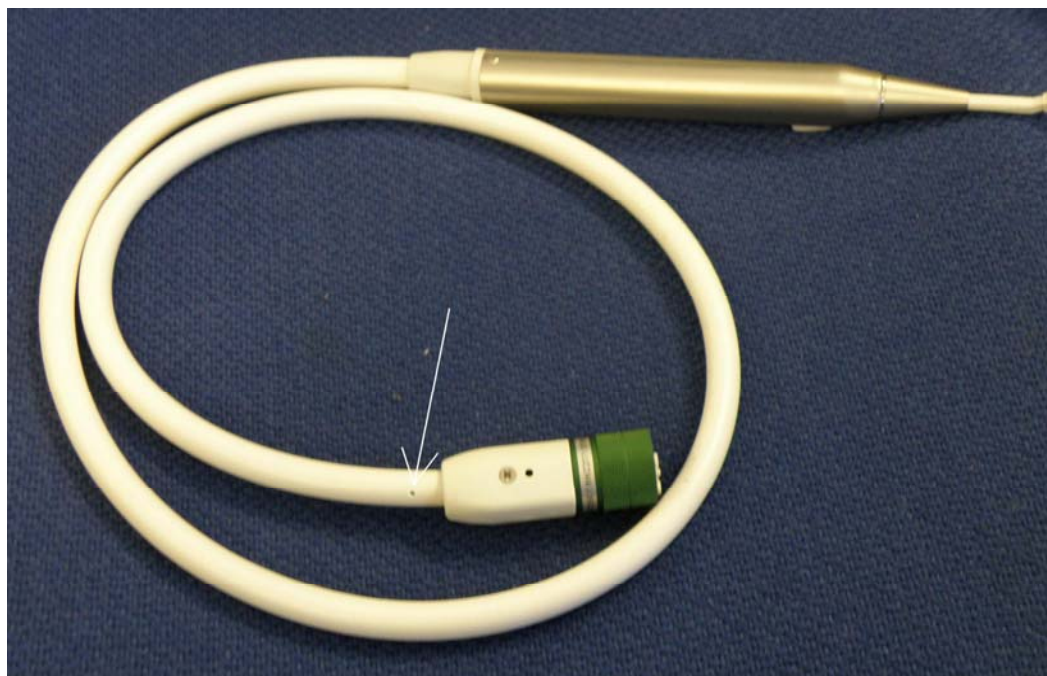
The place of the hole has been changed during the years and is not always possible to see. As a precaution it is recommended that the hole is always added if the hole is not clearly visible (Picture 1).

Picture 1. Instrument hose with the hole

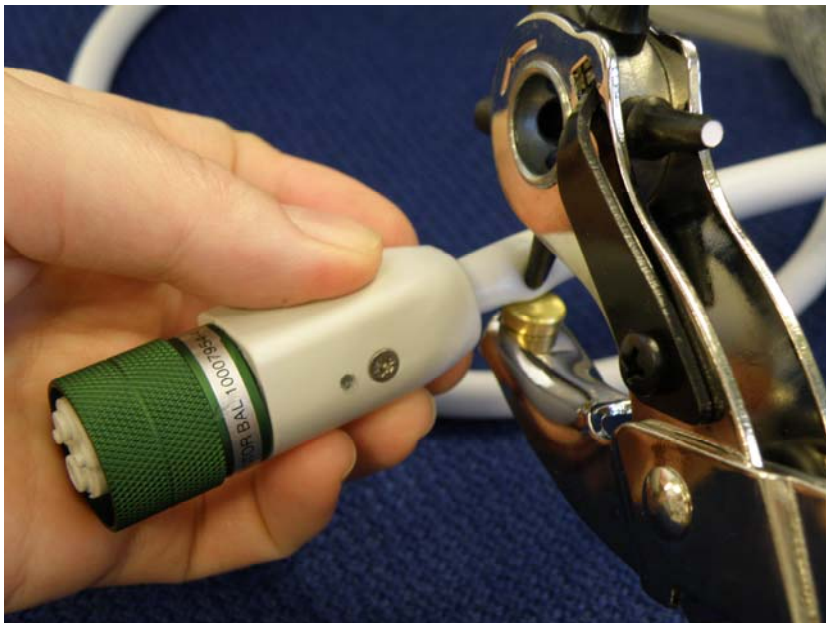
Picture 2. How to make the hole?

It is strongly recommended that the hole is added to all instrument hoses without the hole during the next service visit. Please make the hole carefully according to the picture 2. It is important that the hole is round to prevent hose from splitting. Please be careful not to damage the tubes and wires inside the hose.

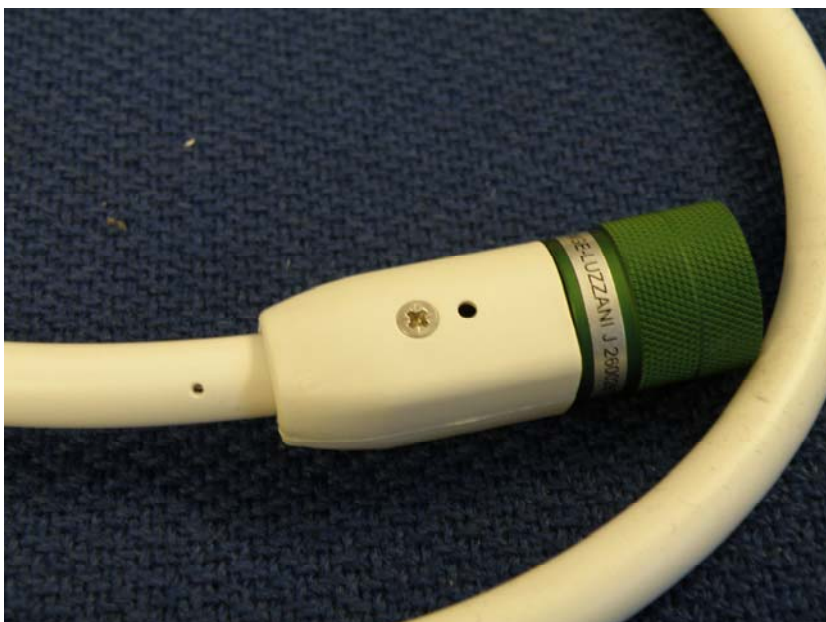
Picture 3. It is important that the hole is round to prevent hose from splitting.
